Environmental Assessment

DEMOLITION OF THE WTJX RADIO STATION

PARCELS NO. 158 & 158A HAYPIECE HILL

APRIL 2023

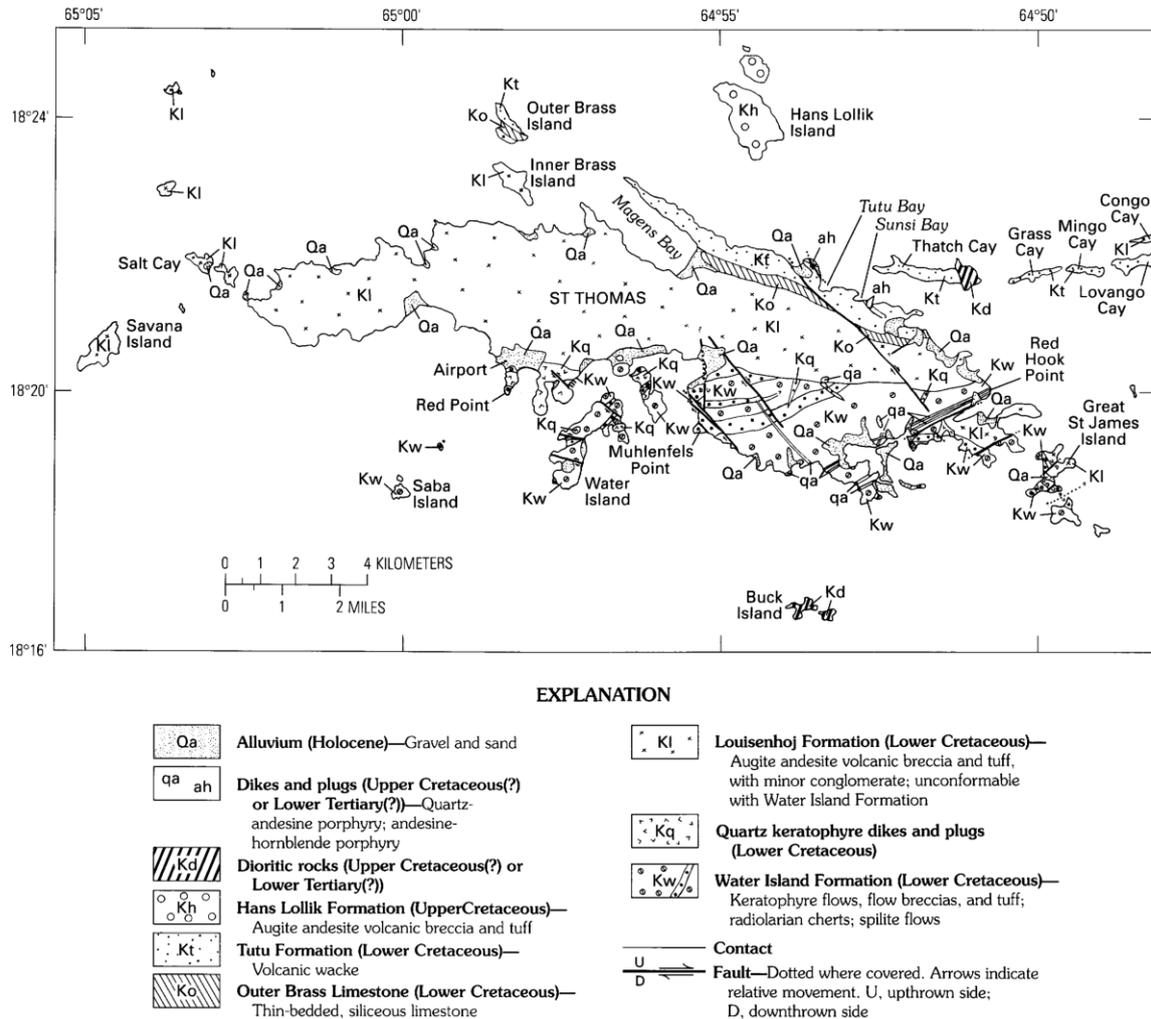
Figure 3. Simplified Geological Map of St. Thomas, Haypiece Hill is Quartz keratophyra dikes and plugs (Lower Cretaceous). (Alminas 1994)

Haypiece Hill is in the middle of a board peninsula extending between Crown Bay and Krum Bay. The peninsula is one large hill and the radio station sits at its crest at 314ft.

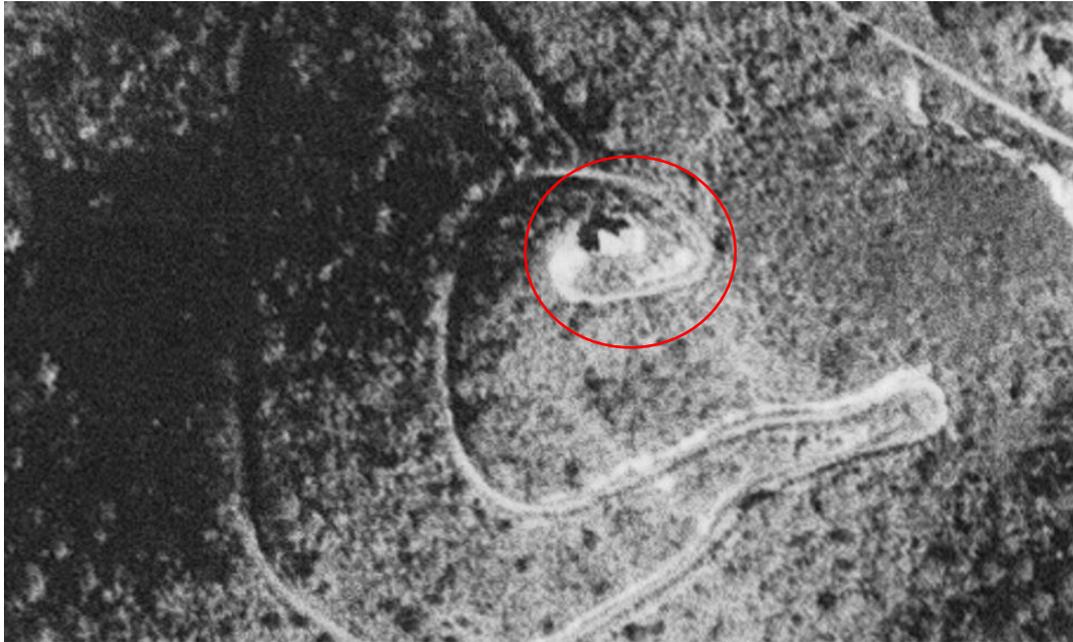
Figure 4. 1954 USGS Aerial Service Map

The photographs below document changes which have been made to the site. The 1954 aerial shows a roadway cut up to the crest of the hill and a building on the top of the hill which was probably associated with military construction during the Naval Occupation of the area. There is no apparent change noted between the 1954 and 1971 but by 1988 the site had been significantly

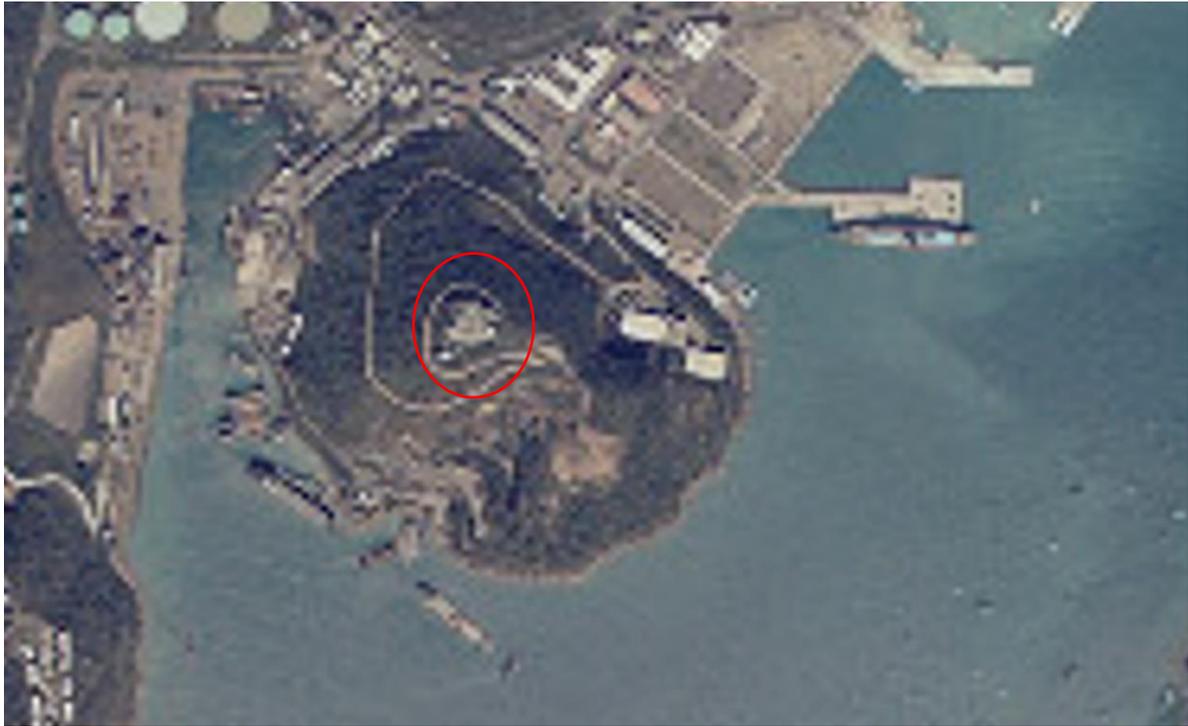
Figure 6. 1988 USGS Aerial Service Map

developed and additional structures were constructed. There is little change on the site between 2003 and 2017 prior to the hurricanes.

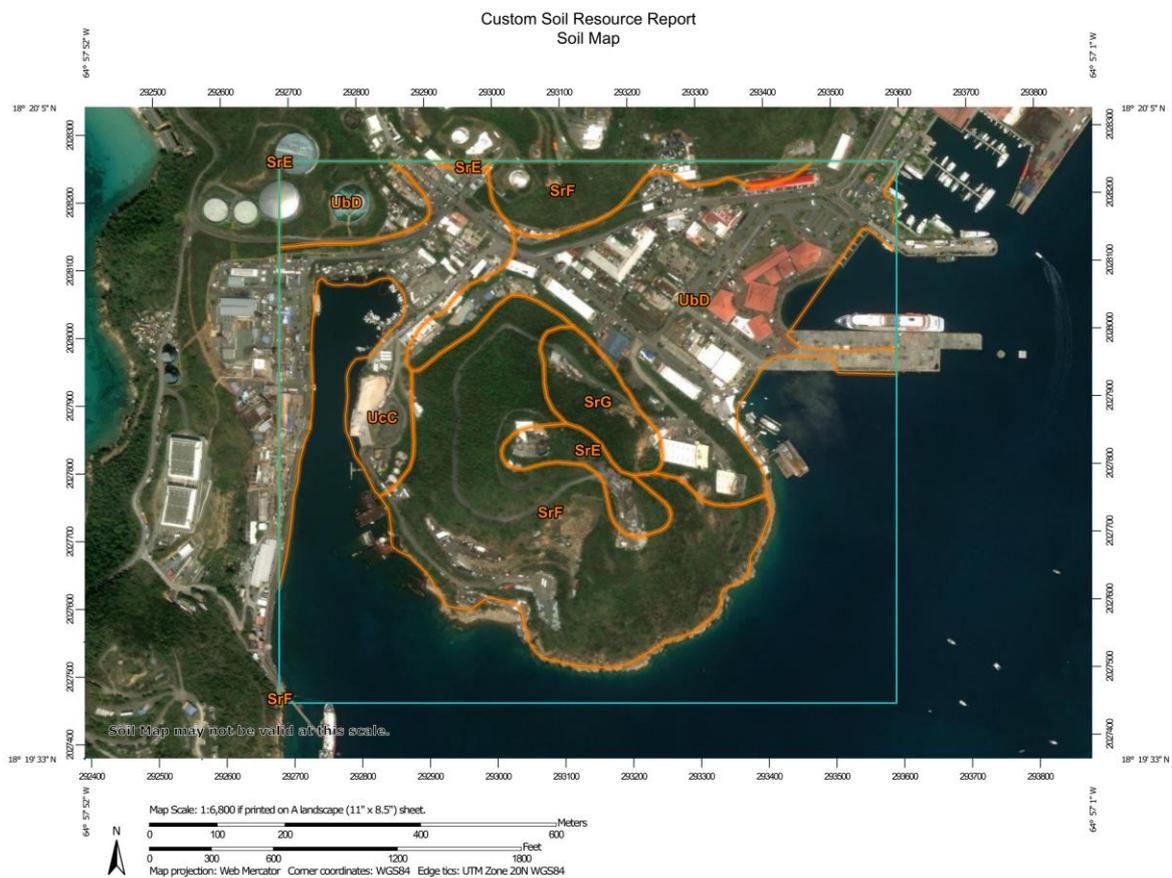
Figure 10. Custom Soil Map for the Haypiece Hill WJTX site.

Two soil types are associated with the WJTX site, according to the Custom Soil Survey of the United States Virgin Islands prepared in 2022. Southgate-Rock outcrop complex, 20 to 40 percent slopes which makes up the southern two-thirds of the site. Southgate-Rock outcrop complex, 20 to 40 percent slopes are found on ridges, mountain slopes and hillsides. These soils are found in areas of 38 to 44 inches of annual precipitation and it is only 10 to 20 inches to a lithic bedrock (restrictive feature). Southgate-Rock outcrop complex (SrF), 40 to 60 percent slopes which makes up the northern third of the site is found in areas of 38 to 44 inches of rainfall annually and it is also 10 to 20 inches to lithic bedrock. These soils are found on mountain tops hillslopes, mountain slopes, and ridges and often have as much as 40% exposed rock outcroppings.

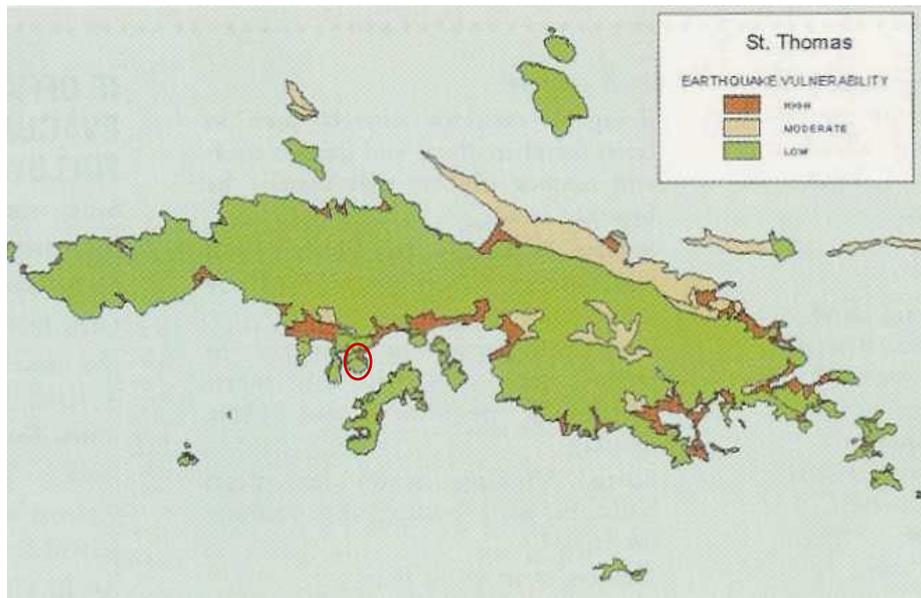
Figure 11. Earthquake Probability Map

its related scarp apparently were thrown up by block faulting during the late Pliocene or early Pleistocene. It is oriented generally northeast to southwest, separating St. Croix from Puerto Rico and the other Virgin Islands. Based on willow focus earthquakes, the Anegada Fault Trough is estimated to be more than 400 miles in length. There are indications that strike slip movement is occurring, with St. Croix shifting northeast relative to Puerto Rico (Puerto Rico Water Authority 1970). Since the 1867 quake, there has been continuous low intensity activity all below 6.0 Richter. Numerous minor tremors are often felt on the island. The project area and Haypiece Hill are in an area of low earthquake vulnerability.

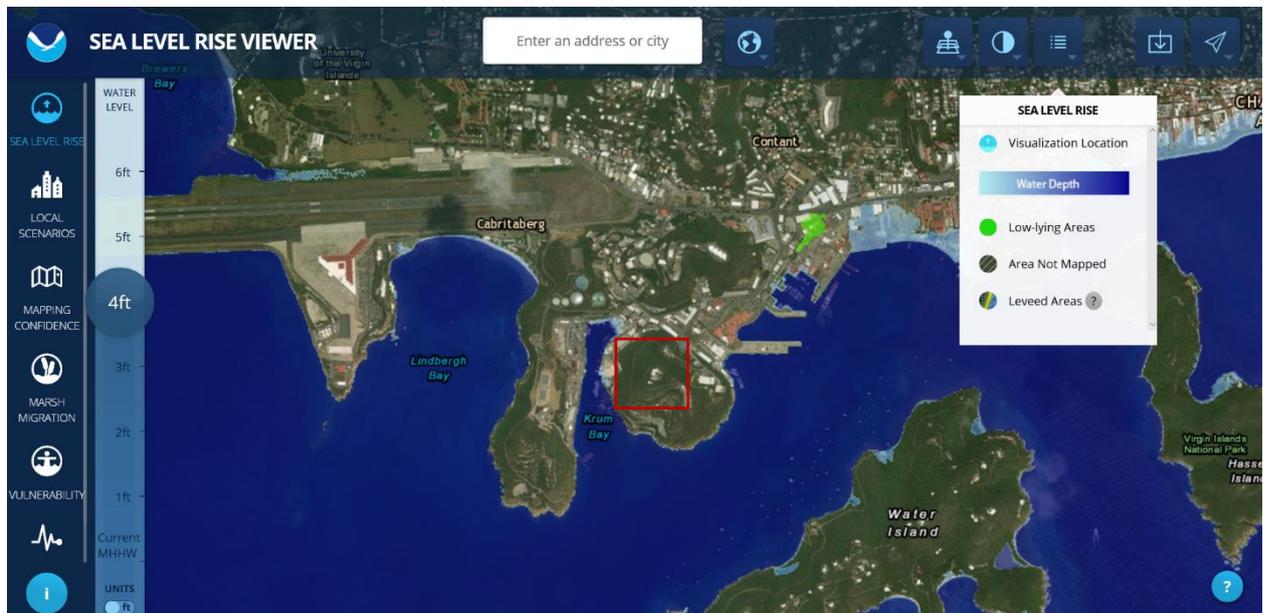
Figure 12. Sea Level Rise Map (<https://coast.noaa.gov/slr/#/layer/slr/4/-7231238.867507785/2076551.6197419522/15/satellite/none/0.56/2050/interHigh/midAccretion>)

According to NOAA's Sea Level Rise Viewer shown below is set to show sea-level rise at 4ft.

The project site will not be affected by sea-level change due to its location at the top of Haypiece Hill.

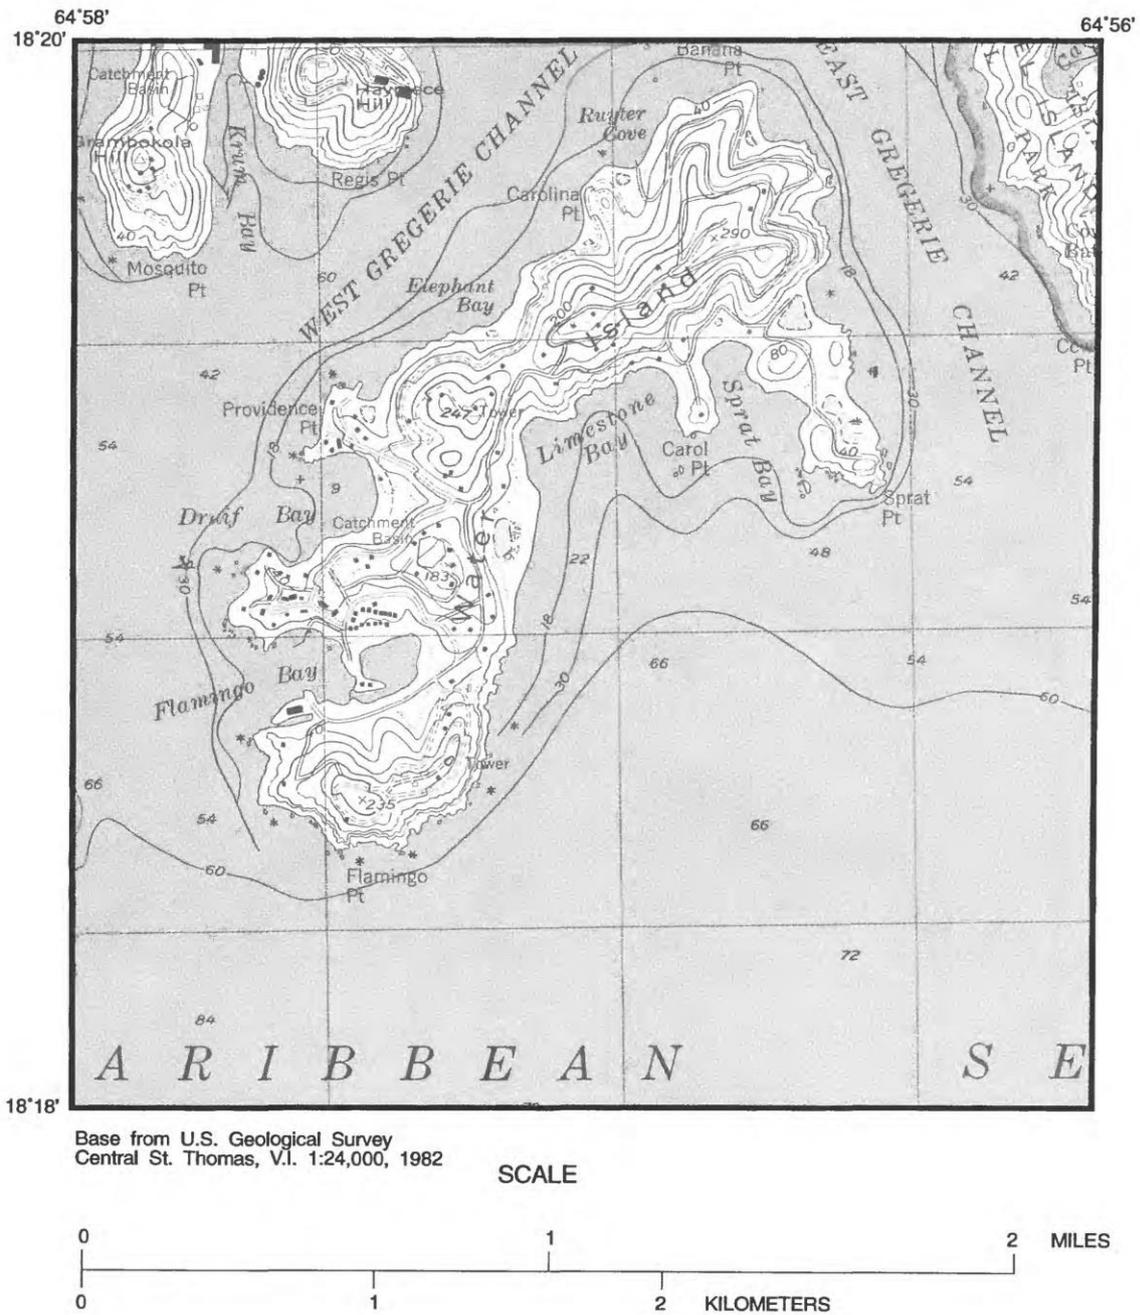
Figure 13. Groundwater well map from Water Wells on St. Thomas, U.S. Virgin Islands, USGS, Open-File Data Report 91-504.

St. Thomas, USVI has limited freshwater resources, which include groundwater wells, intermittent and ephemera streams and ponds which dry up during periods of limited rainfall. Most of the potable water is either captured by rooftops and stored in cisterns or is desalinated seawater. The site does not have freshwater resources. There are no ground water wells in the vicinity of the radio station (Figure 13).

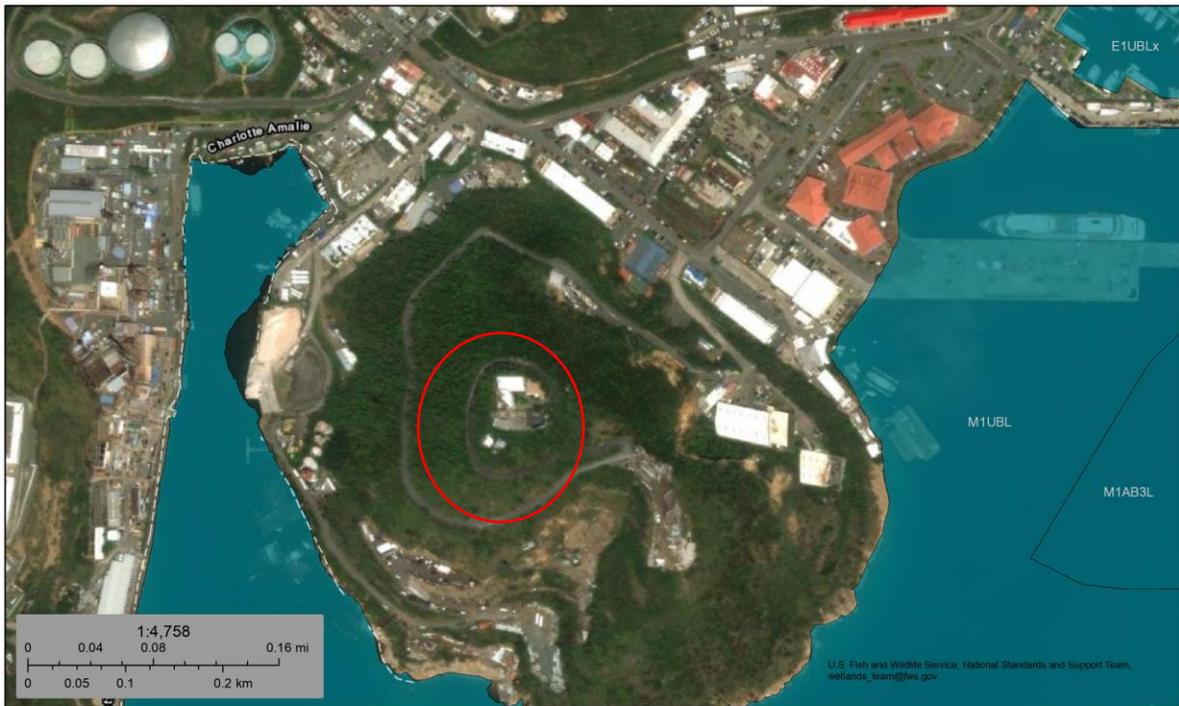
Figure 14. Fish and Wildlife Service Nation Wetland Inventory

There are no terrestrial wetlands within the WJTX Radio Station project site (Figure 14).

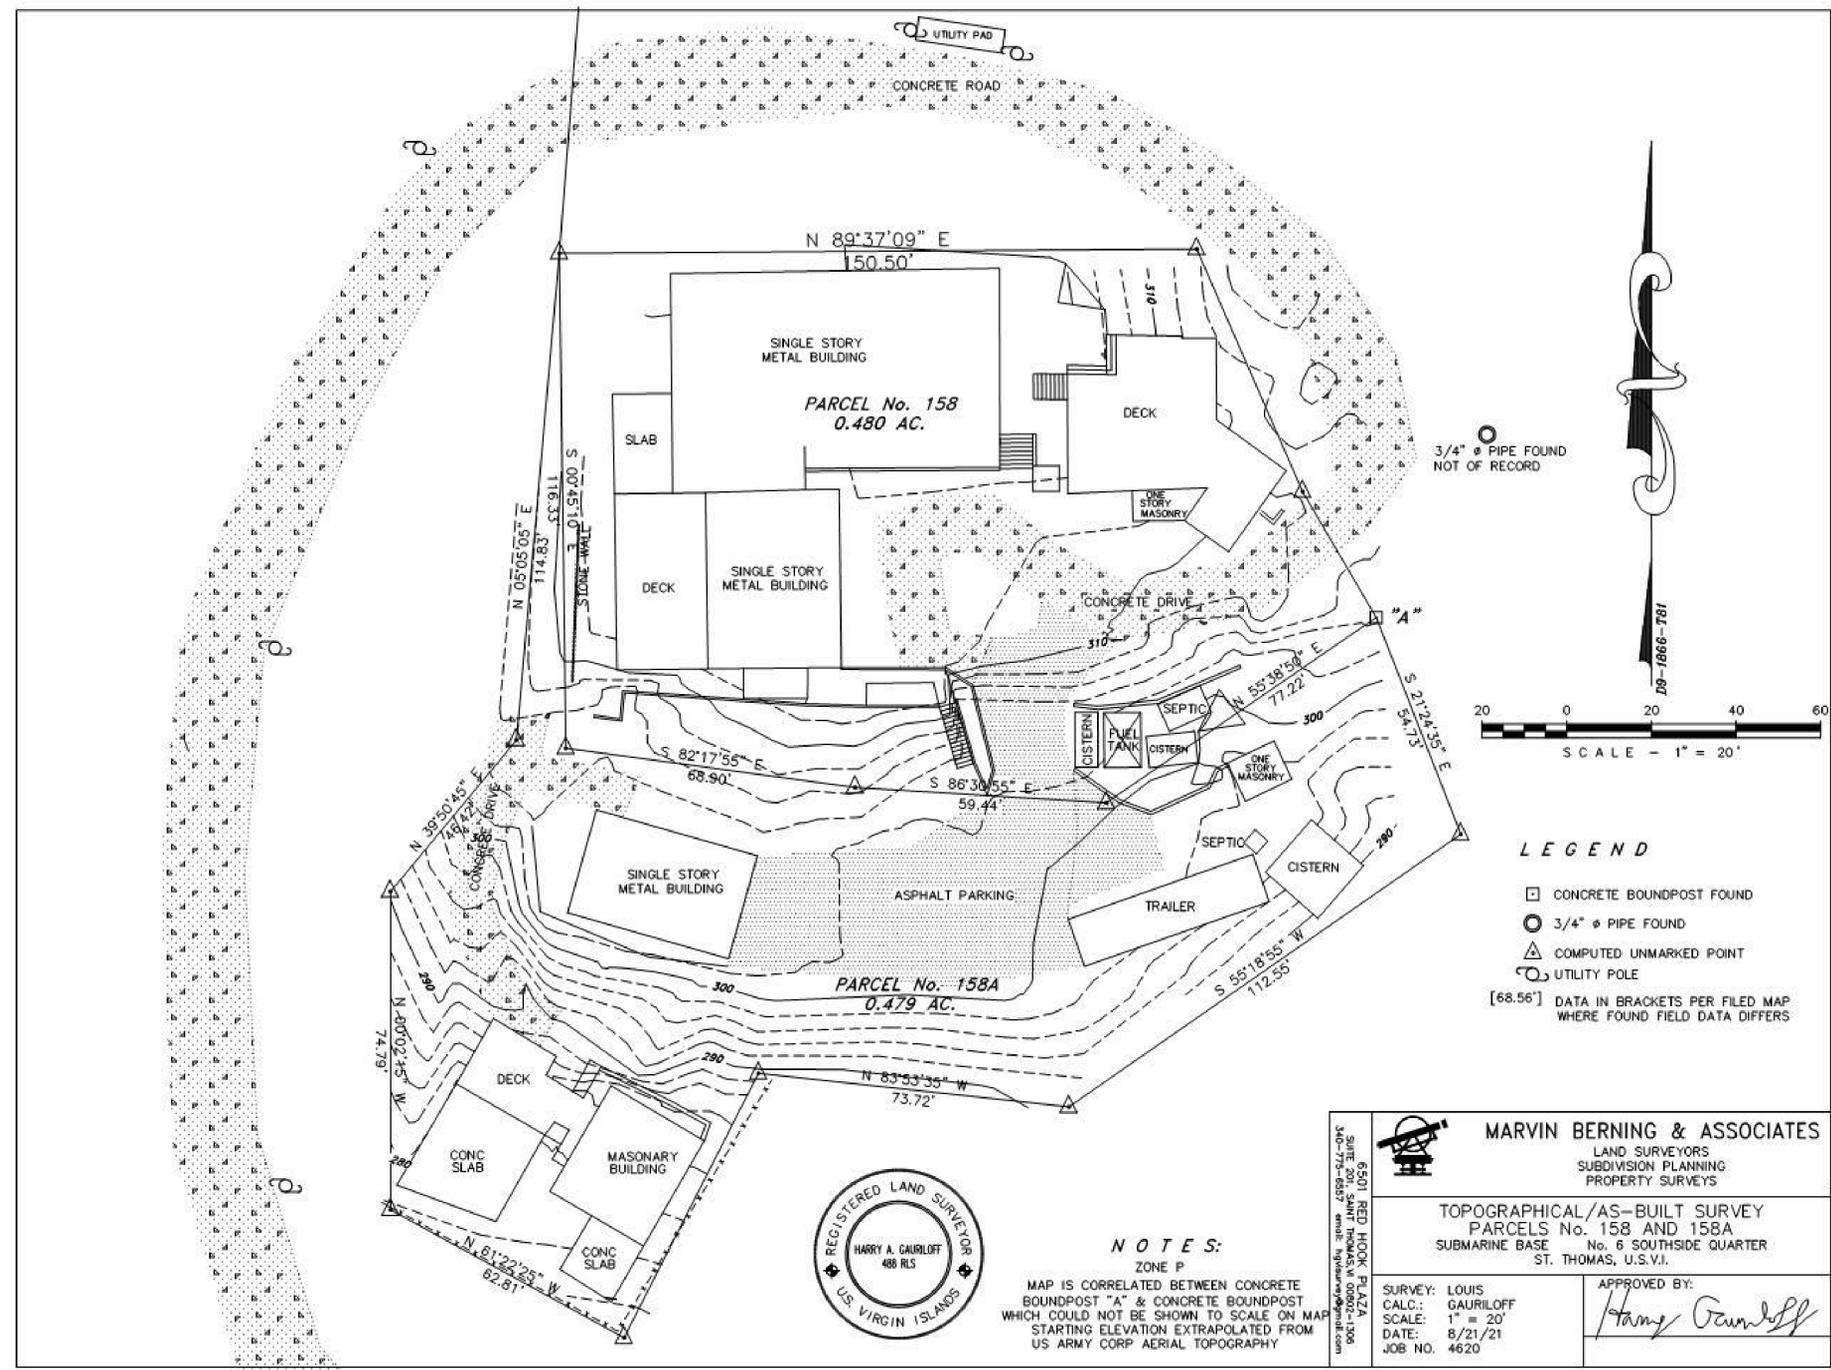
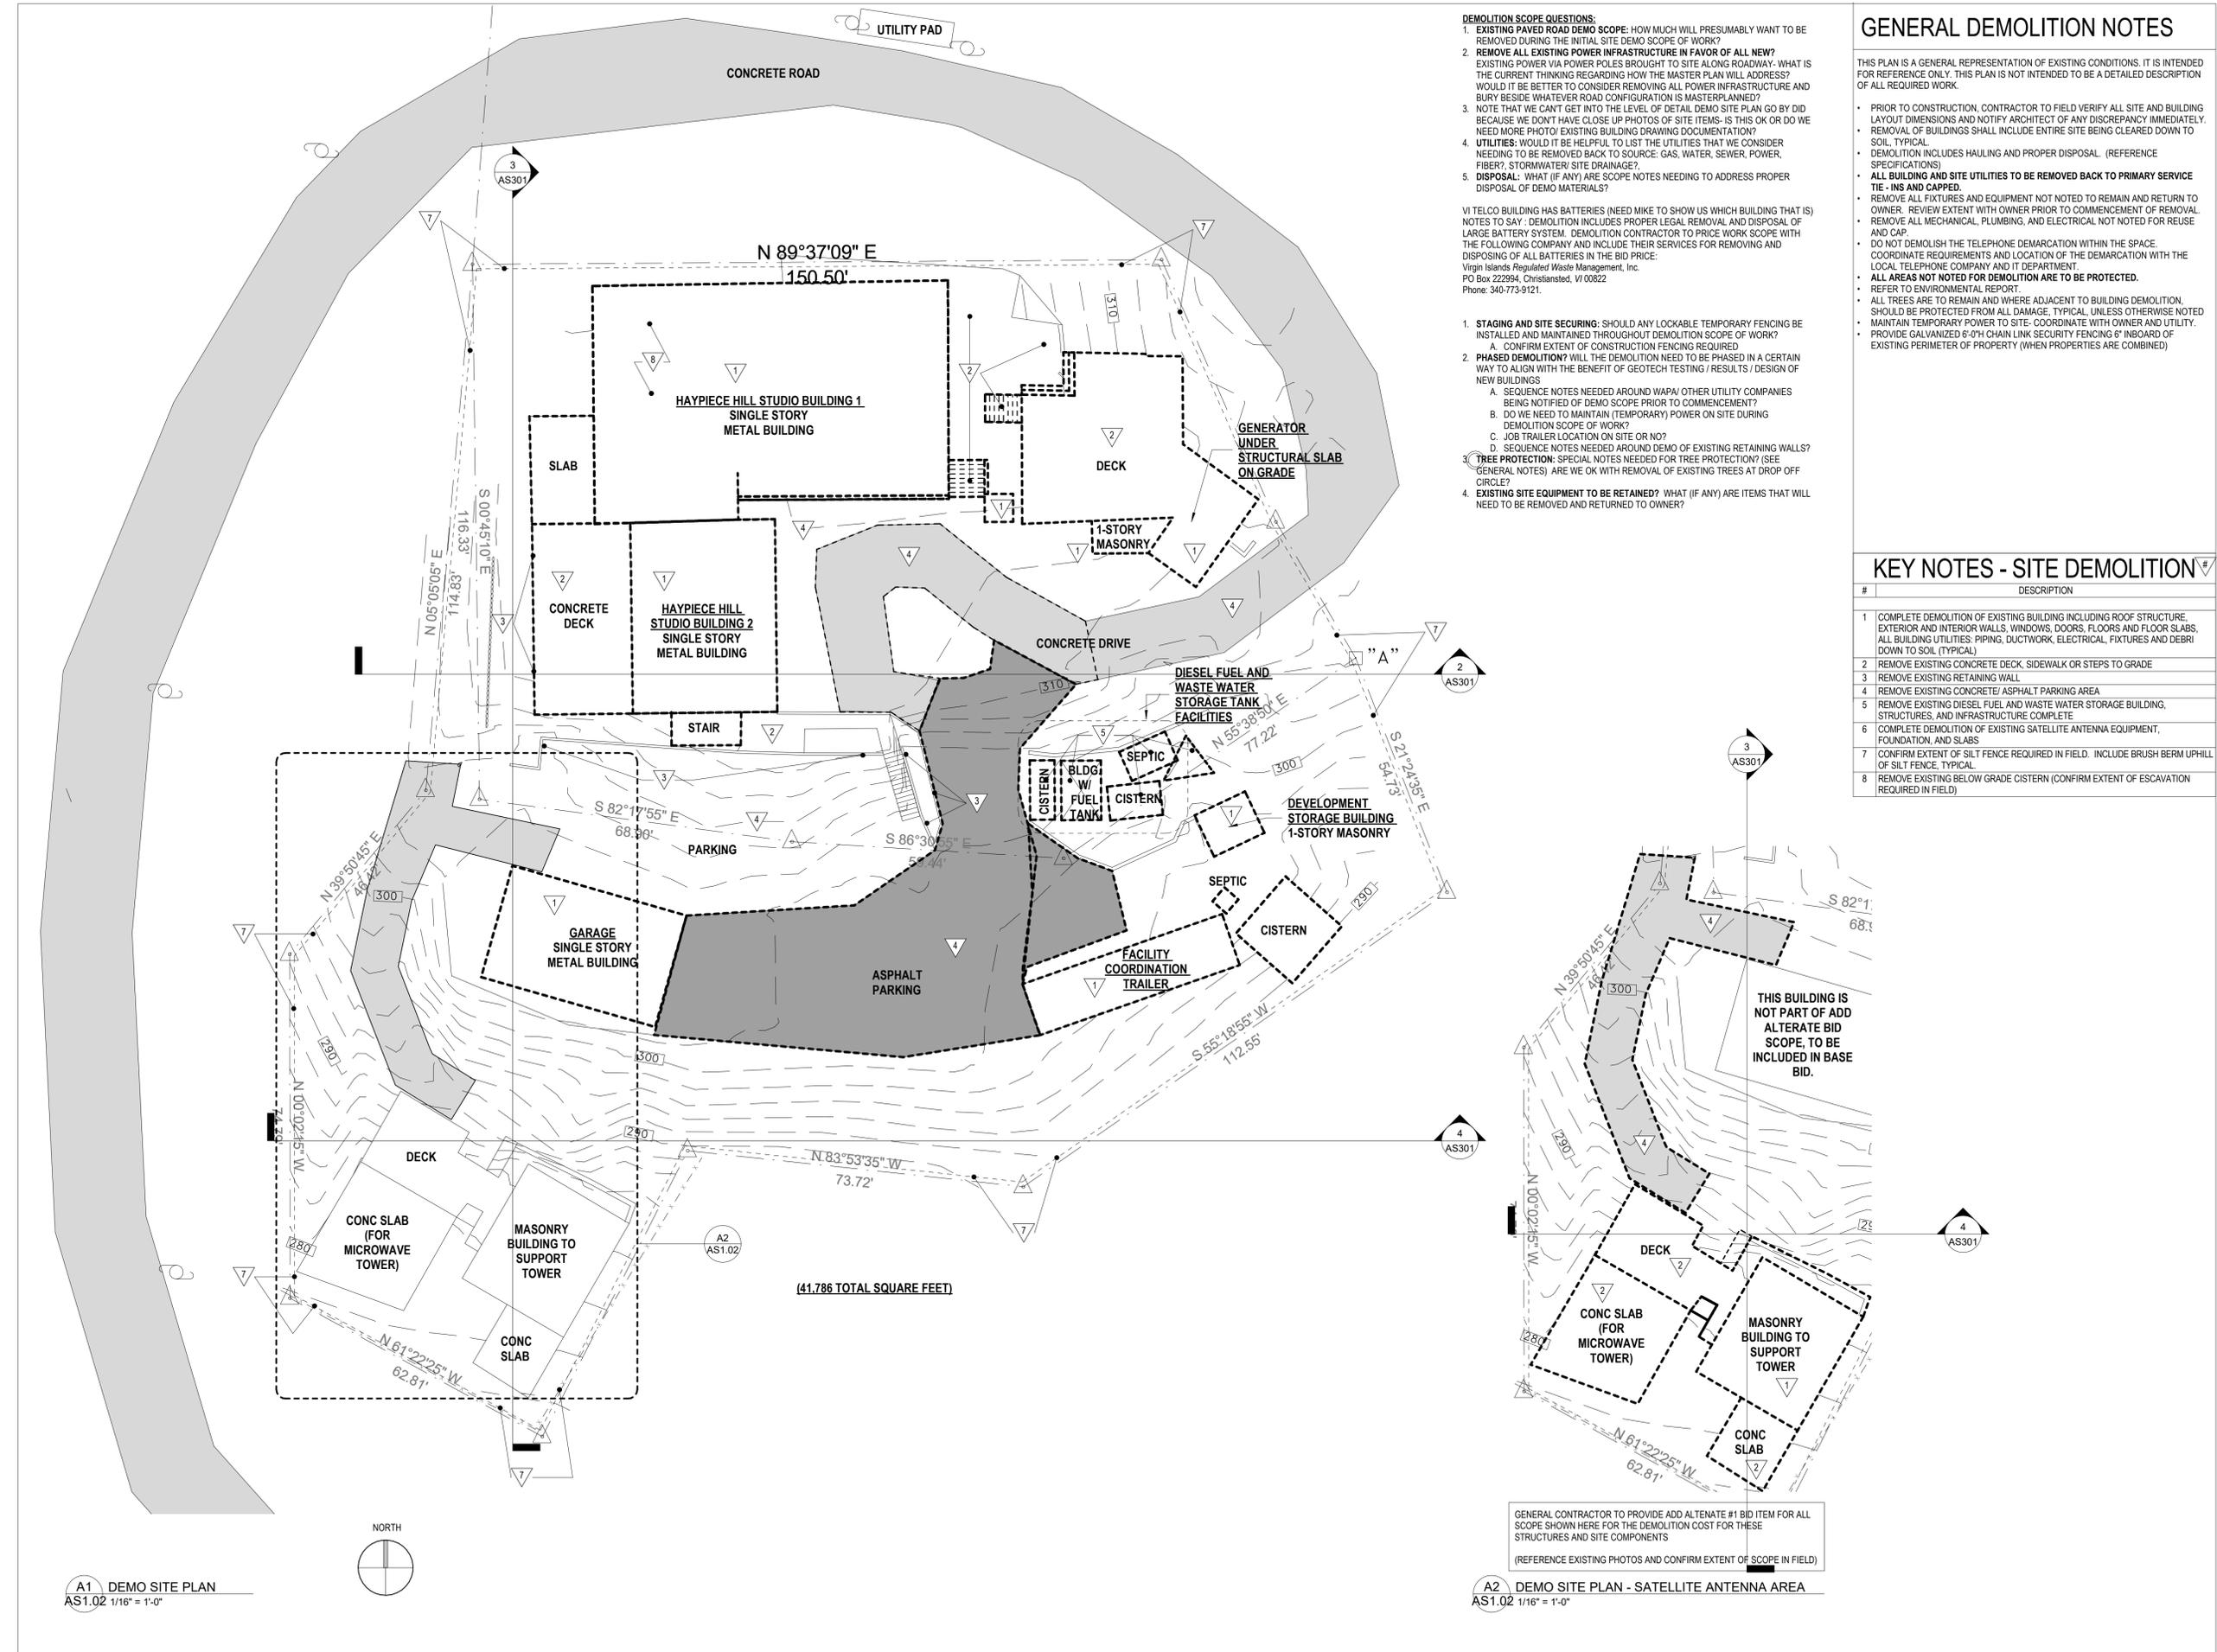
SHEET TITLE: EXISTING CONDITIONS SURVEY

#	DESCRIPTION
1	COMPLETE DEMOLITION OF EXISTING BUILDING INCLUDING ROOF STRUCTURE, EXTERIOR AND INTERIOR WALLS, WINDOWS, DOORS, FLOORS AND FLOOR SLABS, ALL BUILDING UTILITIES, PIPING, DUCTWORK, ELECTRICAL, FIXTURES AND DEBRIS DOWN TO SOIL (TYPICAL)
2	REMOVE EXISTING CONCRETE DECK, SIDEWALK OR STEPS TO GRADE
3	REMOVE EXISTING RETAINING WALL
4	REMOVE EXISTING CONCRETE/ ASPHALT PARKING AREA
5	REMOVE EXISTING DIESEL FUEL AND WASTE WATER STORAGE BUILDING, STRUCTURES, AND INFRASTRUCTURE COMPLETE
6	COMPLETE DEMOLITION OF EXISTING SATELLITE ANTENNA EQUIPMENT, FOUNDATION, AND SLABS
7	CONFIRM EXTENT OF SILT FENCE REQUIRED IN FIELD. INCLUDE BRUSH BERM UPHILL OF SILT FENCE, TYPICAL.
8	REMOVE EXISTING BELOW GRADE CISTERN (CONFIRM EXTENT OF ESCAVATION REQUIRED IN FIELD)

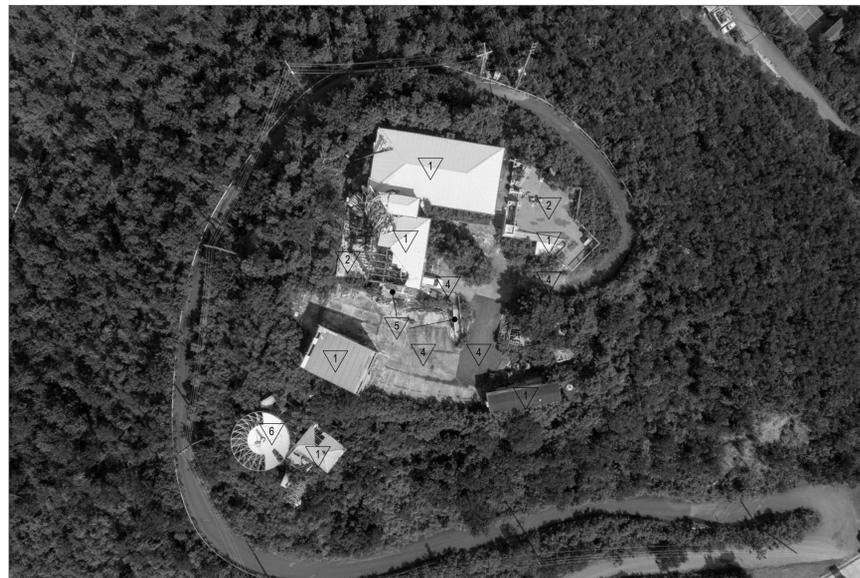
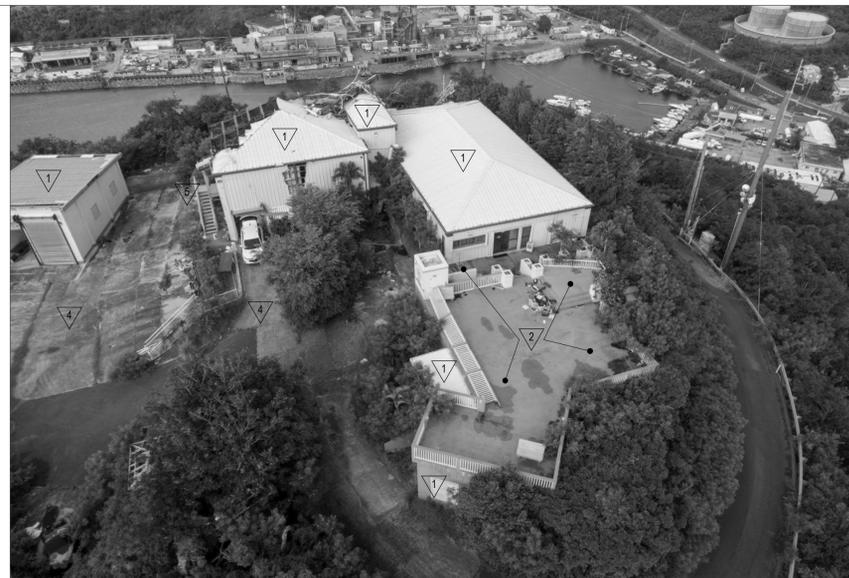
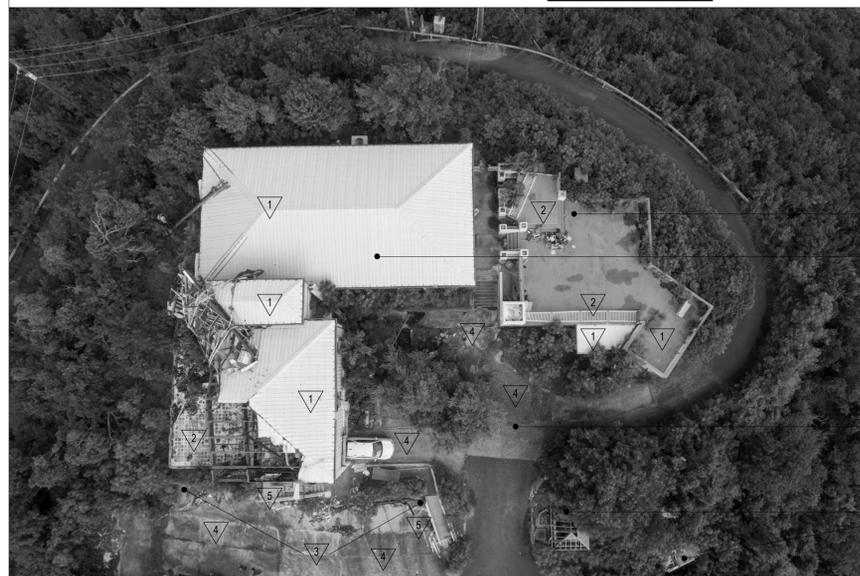
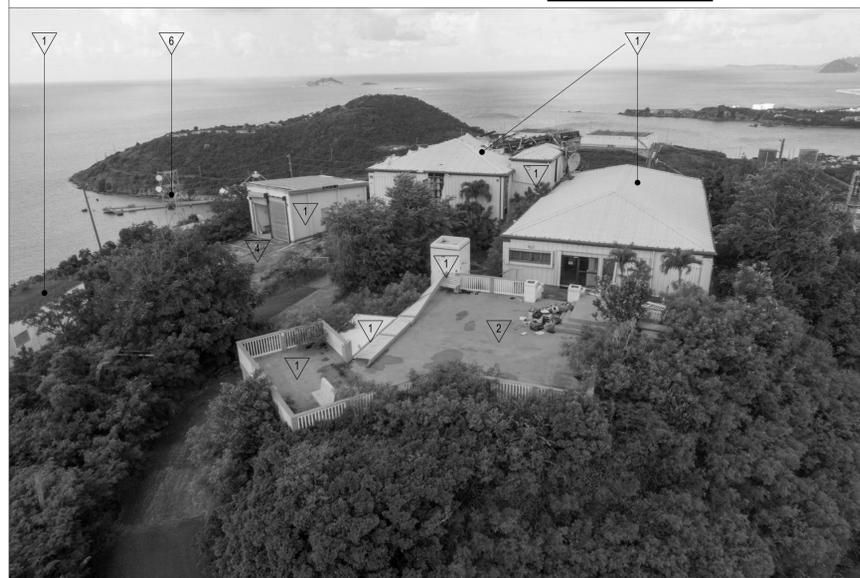
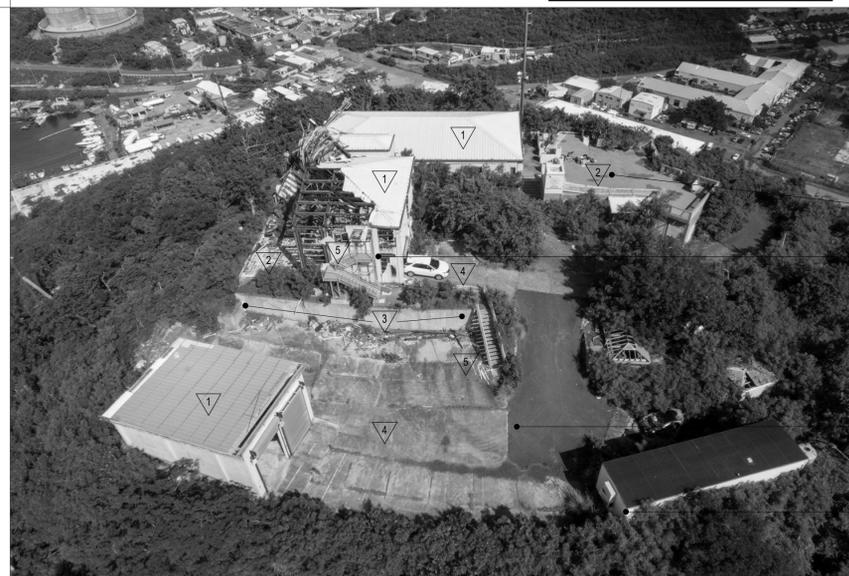
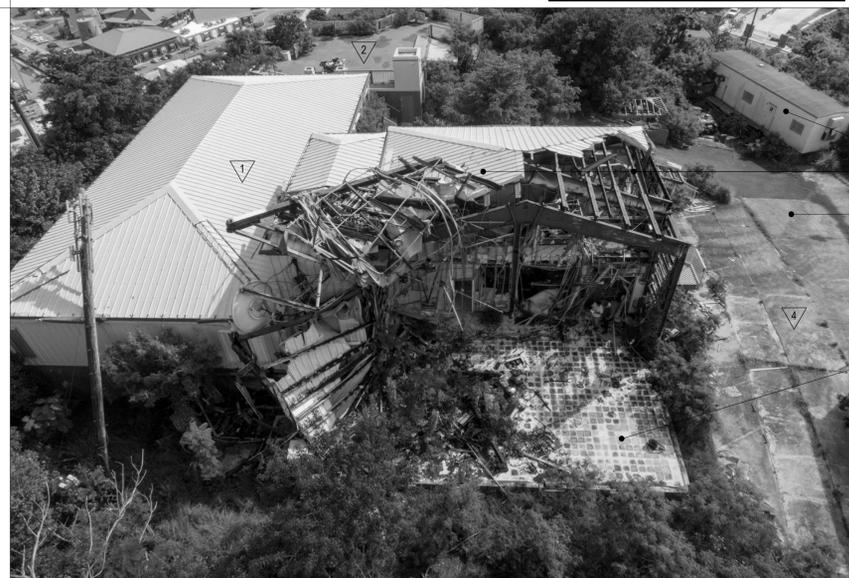
SITE CONDITIONS REFERENCES

THESE PHOTOS ARE FOR GENERAL REPRESENTATION OF EXISTING CONDITIONS. IT IS INTENDED FOR REFERENCE ONLY. EXTENT OF SCOPE TO BE CONFIRMED IN FIELD.

#	DESCRIPTION
1	COMPLETE DEMOLITION OF EXISTING BUILDING INCLUDING ROOF STRUCTURE, EXTERIOR AND INTERIOR WALLS, WINDOWS, DOORS, FLOORS AND FLOOR SLABS, ALL BUILDING UTILITIES, PIPING, DUCTWORK, ELECTRICAL, FIXTURES AND DEBRIS DOWN TO SOIL, (TYPICAL)
2	REMOVE EXISTING CONCRETE DECK, SIDEWALK OR STEPS TO GRADE
3	REMOVE EXISTING RETAINING WALL
4	REMOVE EXISTING CONCRETE/ ASPHALT PARKING AREA
5	REMOVE EXISTING DIESEL FUEL AND WASTE WATER STORAGE BUILDING, STRUCTURES, AND INFRASTRUCTURE COMPLETE
6	COMPLETE DEMOLITION OF EXISTING SATELLITE ANTENNA EQUIPMENT, FOUNDATION, AND SLABS

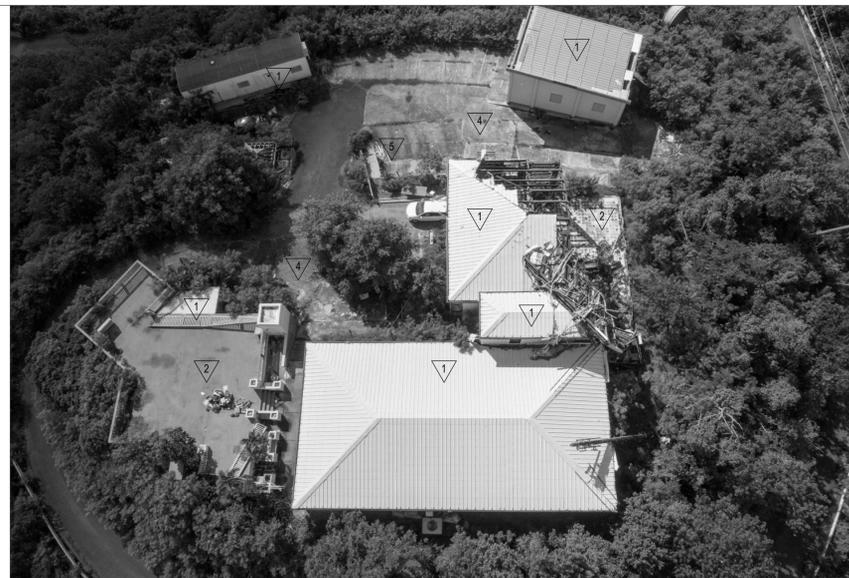
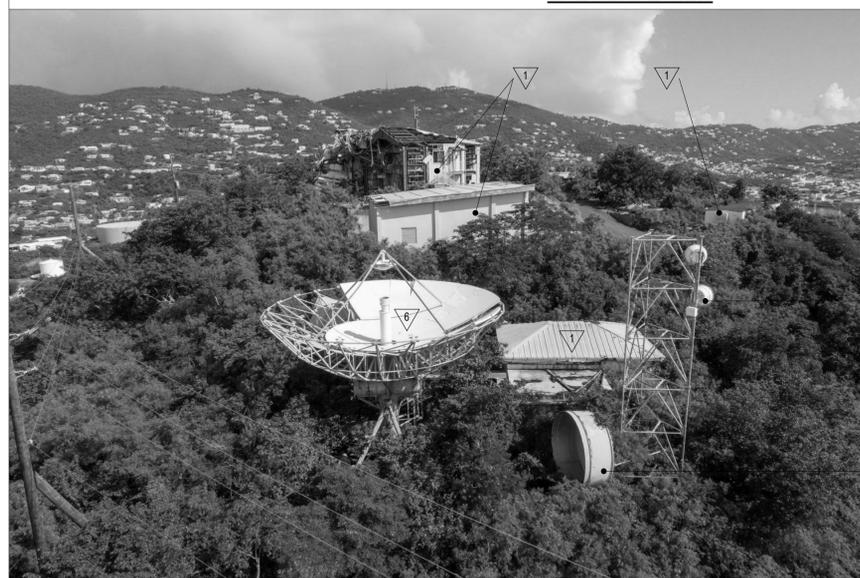
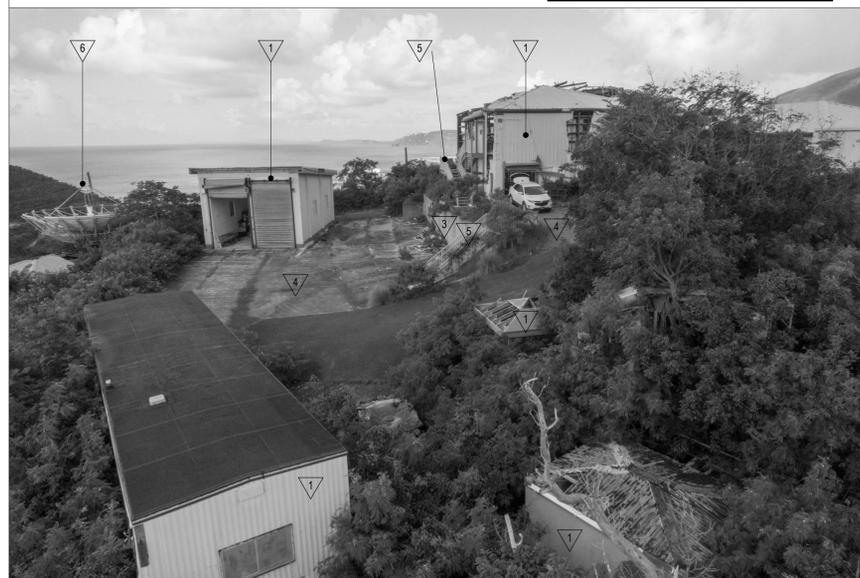
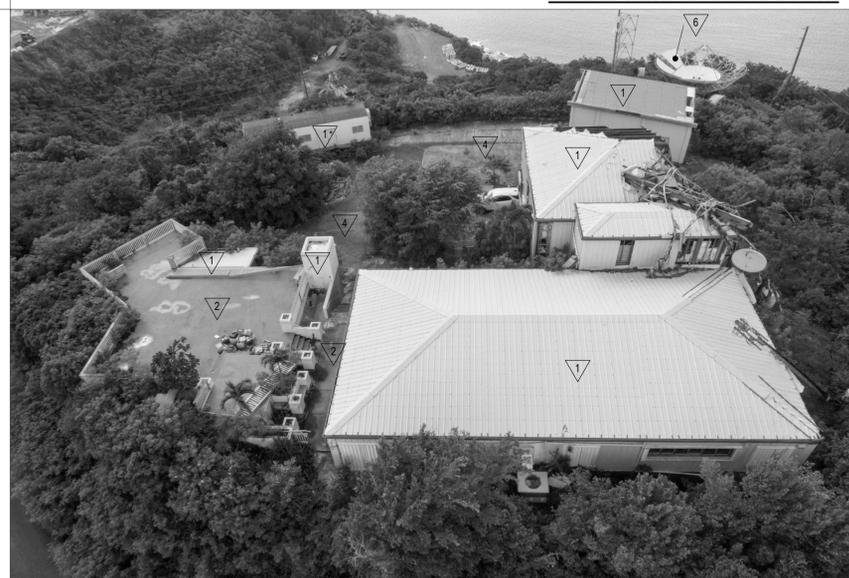
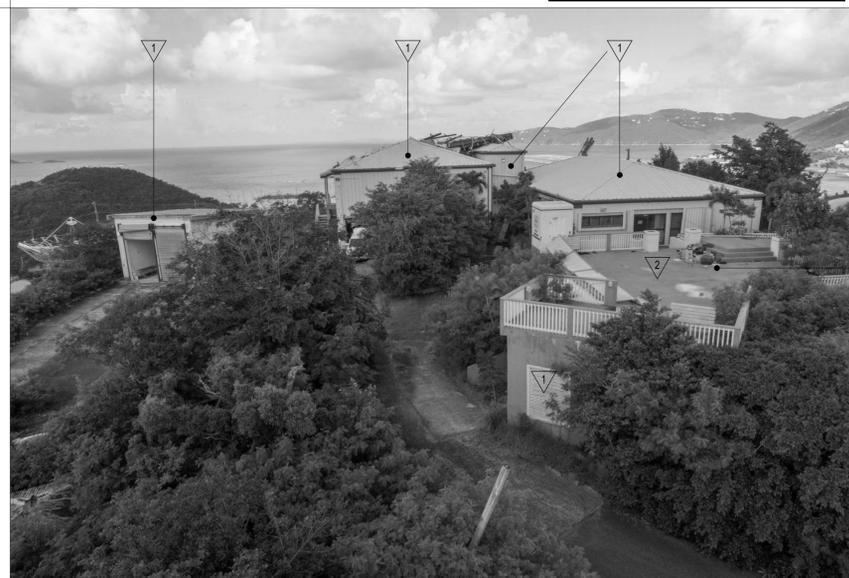
SITE CONDITIONS REFERENCES

THESE PHOTOS ARE FOR GENERAL REPRESENTATION OF EXISTING CONDITIONS. IT IS INTENDED FOR REFERENCE ONLY. EXTENT OF SCOPE TO BE CONFIRMED IN FIELD.

#	DESCRIPTION
1	COMPLETE DEMOLITION OF EXISTING BUILDING INCLUDING ROOF STRUCTURE, EXTERIOR AND INTERIOR WALLS, WINDOWS, DOORS, FLOORS AND FLOOR SLABS, ALL BUILDING UTILITIES, PIPING, DUCTWORK, ELECTRICAL, FIXTURES AND DEBRIS DOWN TO SOIL, (TYPICAL)
2	REMOVE EXISTING CONCRETE DECK, SIDEWALK OR STEPS TO GRADE
3	REMOVE EXISTING RETAINING WALL
4	REMOVE EXISTING CONCRETE/ ASPHALT PARKING AREA
5	REMOVE EXISTING DIESEL FUEL AND WASTE WATER STORAGE BUILDING, STRUCTURES, AND INFRASTRUCTURE COMPLETE
6	COMPLETE DEMOLITION OF EXISTING SATELLITE ANTENNA EQUIPMENT, FOUNDATION, AND SLABS
